Balance rod failure in a 2006 Toyota Prado

The engine: Toyota 3RZ-FE

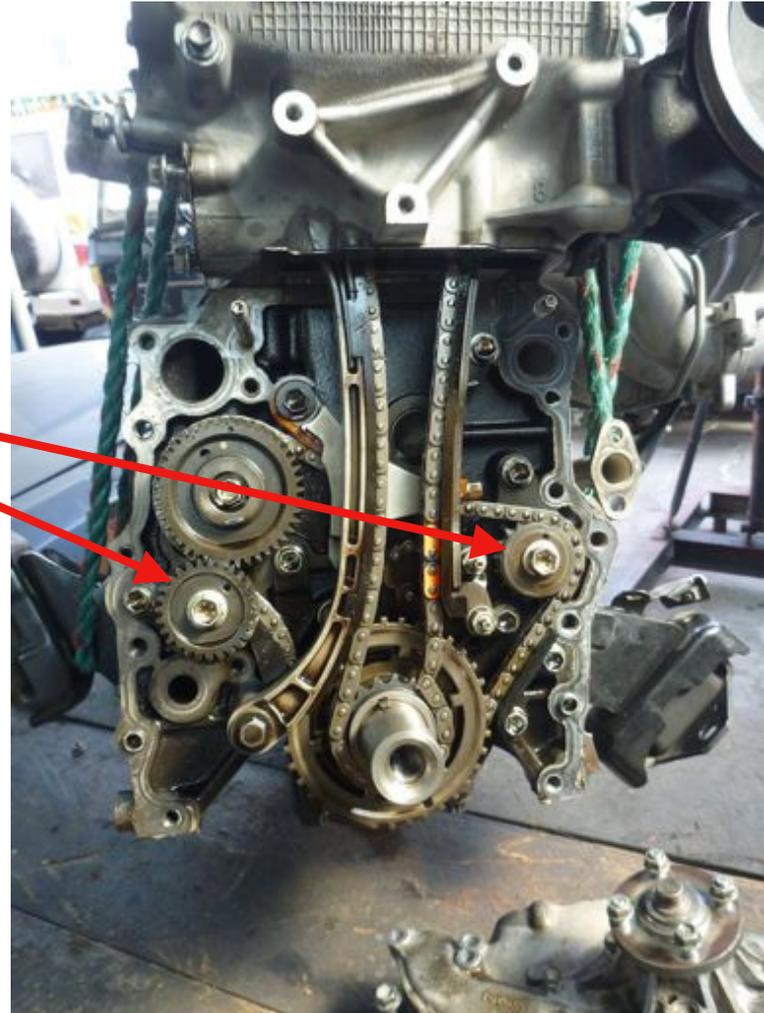
Twin balance shafts
(failed shaft on the left)

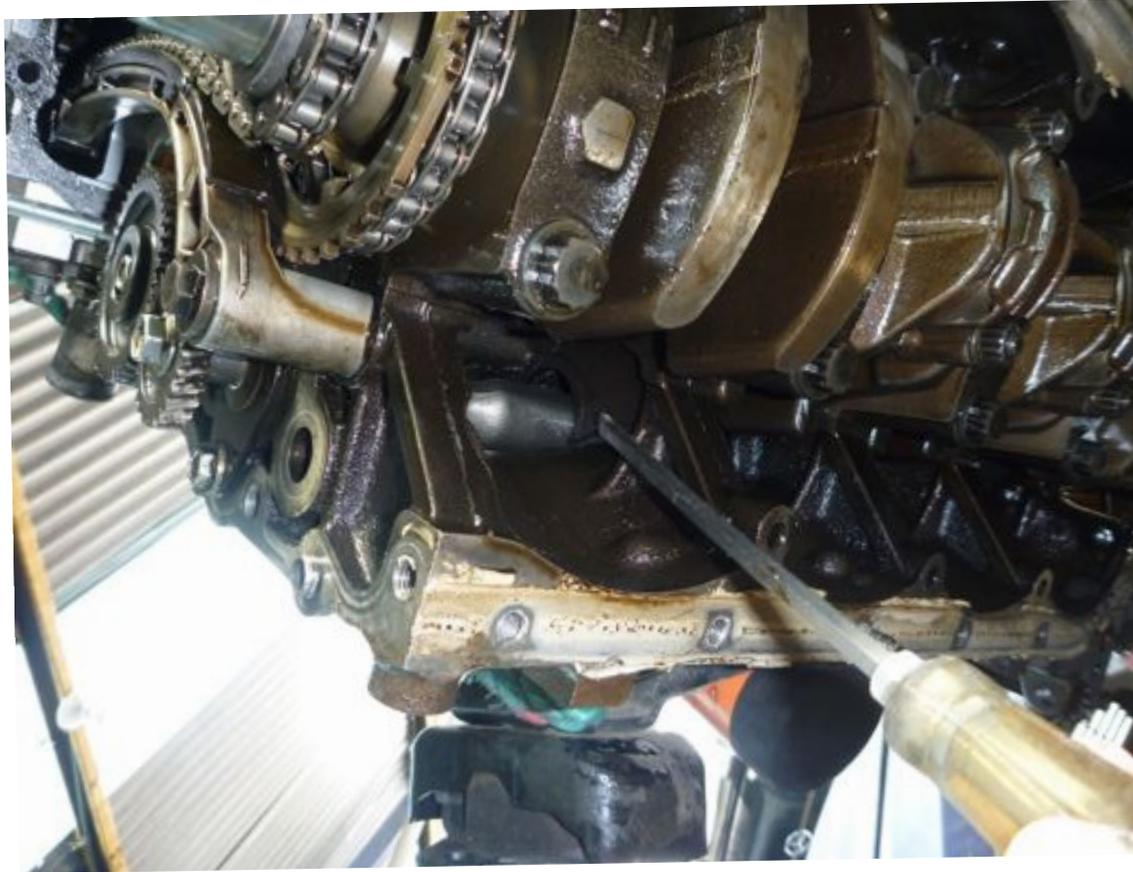
Failed balance shaft seal

This led to damage to the block and sent metal shards into the engine, damaging the oil pump and potentially other areas.

According to a mechanic at Toyota in Quito, the problem was tied to not using the recommended grade oil/filter and change intervals, and/or abusive engine use. A mechanic from a local machine shop told me that they had repaired over a dozen Toyota engines with the same problem in the last two years. In each case, the engine had between 50,000 and 75,000 miles when a balance rod seal failed. The machine shop recommended eliminating the balance shafts and welding shut the holes.

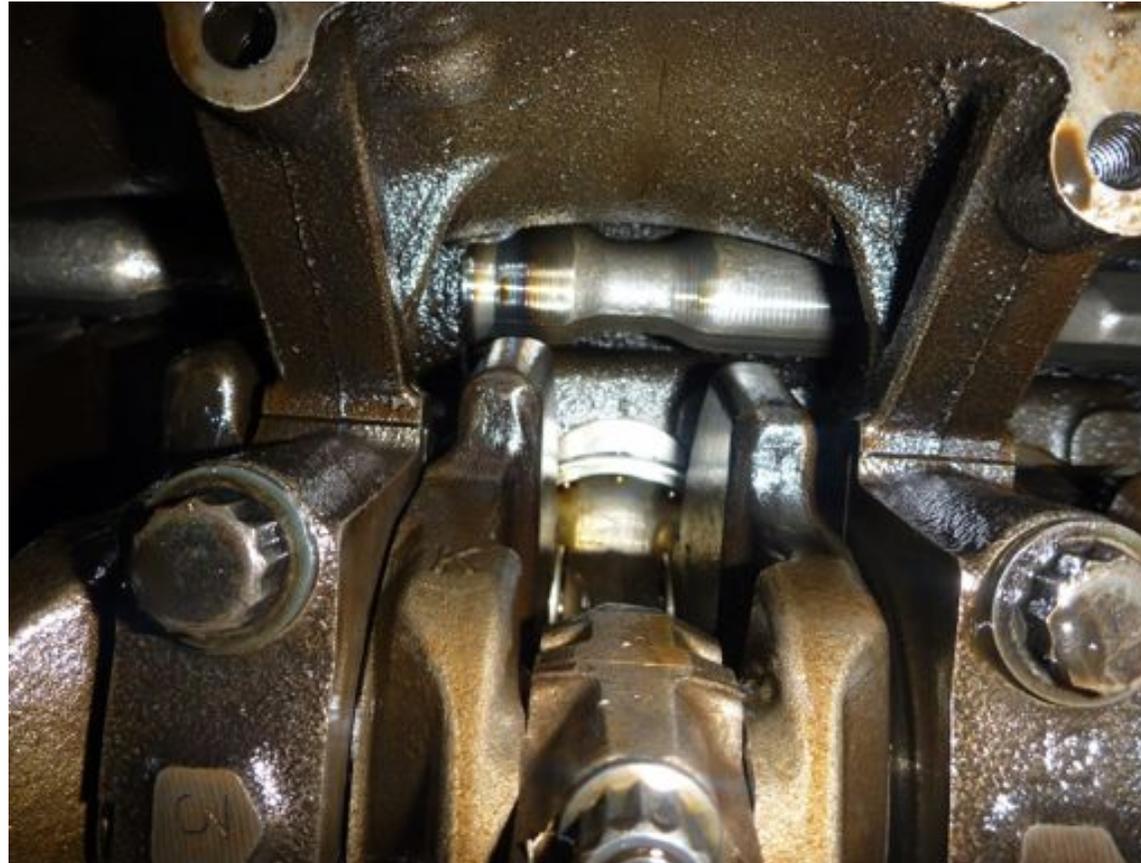
Heating and warping damage to balance shaft (and block)
