CONTENTS

SQUEAK AND RATTLE TROUBLE DIAGNOSES

INSTRUMENT PANEL ASSEMBLY

CENTER CONSOLE ASSEMBLY

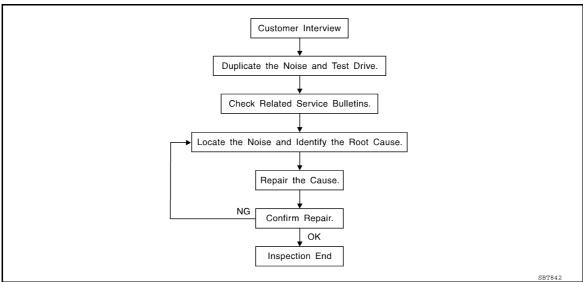
Work Flow

CUSTOMER INTERVIEW

Interview the customer if possible, to determine the conditions that exist when the noise occurs. Use the Diagnostic Worksheet during the interview to document the facts and conditions when the noise occurs and any customer's comments; refer to IP-8, "Diagnostic Worksheet". This information is necessary to duplicate the conditions that exist when the noise occurs.

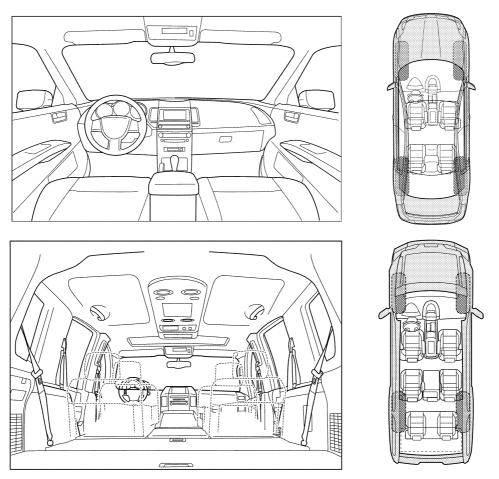
I. WHERE DOES THE NOISE COME FROM? (circle the area of the vehicle)

The illustrations are for reference only, and may not reflect the actual configuration of your vehicle.

Continue to page 2 of the worksheet and briefly describe the location of the noise or rattle. In addition, please indicate the conditions which are present when the noise occurs.

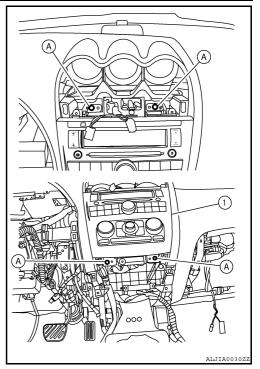
- 13. Remove the cluster lid C assembly upper and lower screws (A), then remove the cluster lid C assembly (1).
 - Disconnect the harness connectors.

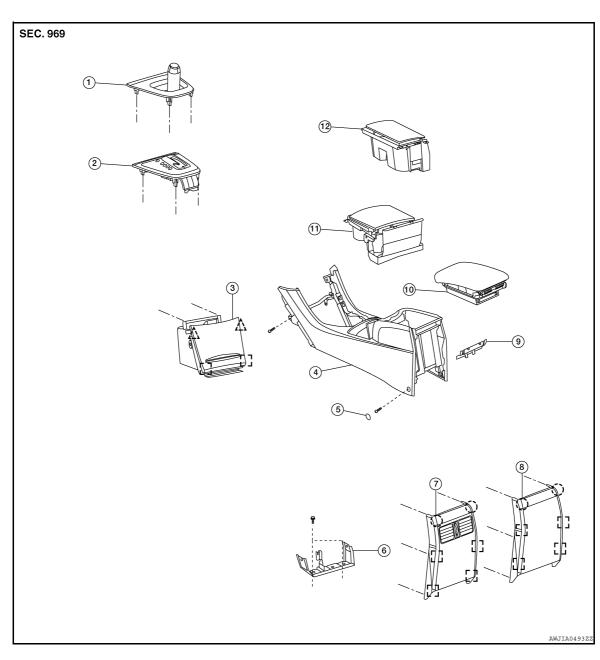
Exploded View INFOID:0000000005434174

- M/T finisher
- 4. Console
- Console rear finisher (with rear duct)
- Console lid assembly
- (_) Clip

- 2. CVT finisher
- Console screw cover (LH)
- Console rear finisher (without rear 9. duct)
- 11. Cup holder CVT
- Pawl
